## Concrete Supply Company – Mauldin Plant

### Unpermitted Industrial Stormwater Inspection SC

December 11, 2018

SW-CSCMauldin-12/11/18

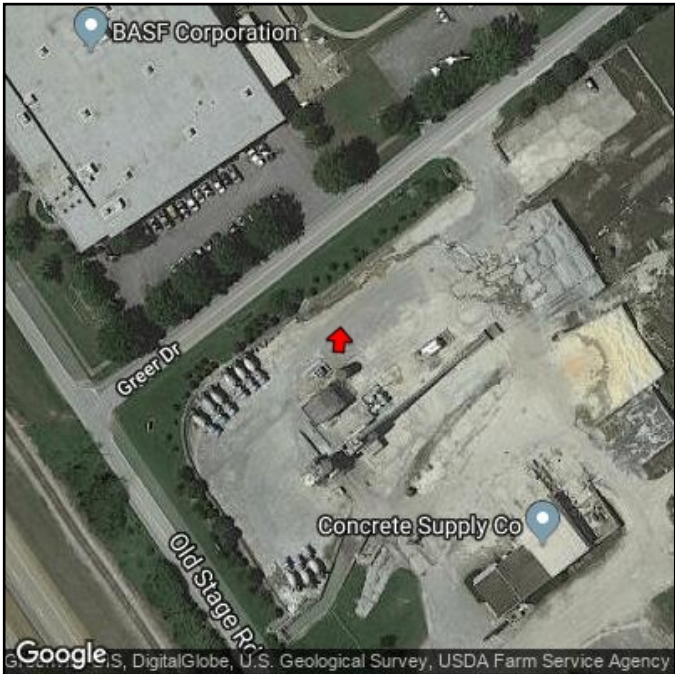
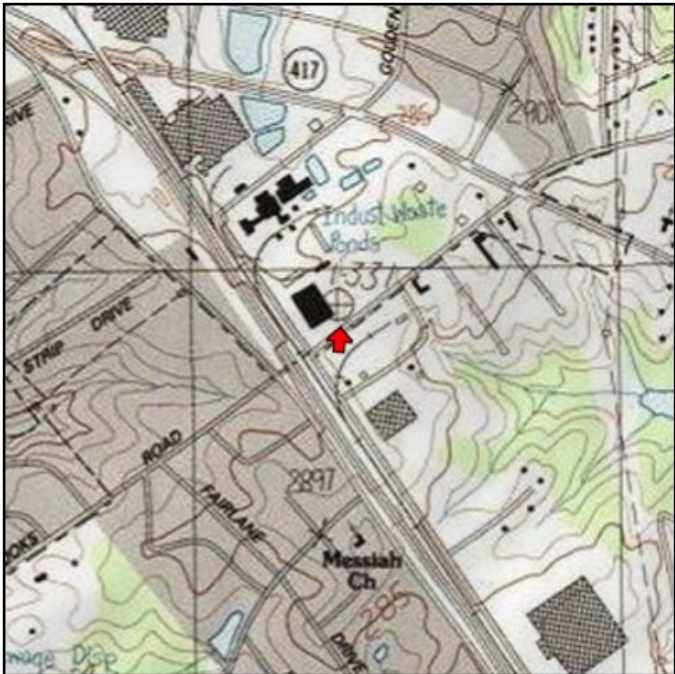
Attributes	
Description	Prior Outfall #1 is at base of wall in background. The facility stated that they have blocked the outfall and no longer treat it as an outfall. Evidence of ongoing drainage off-site at this location was visible from the NW side of the wall.

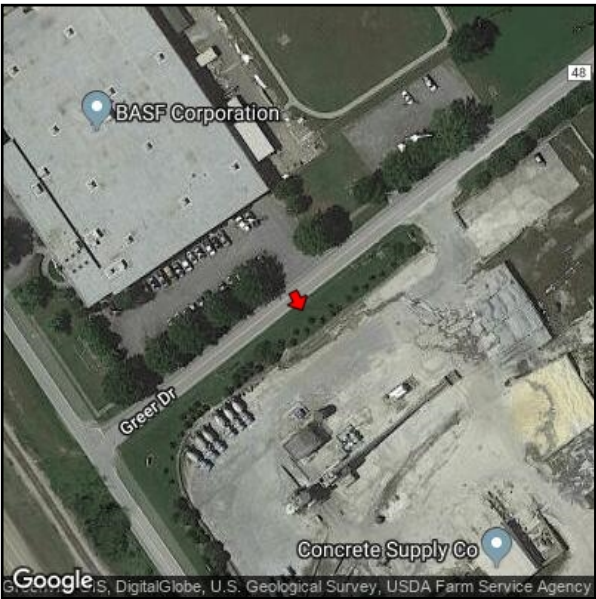
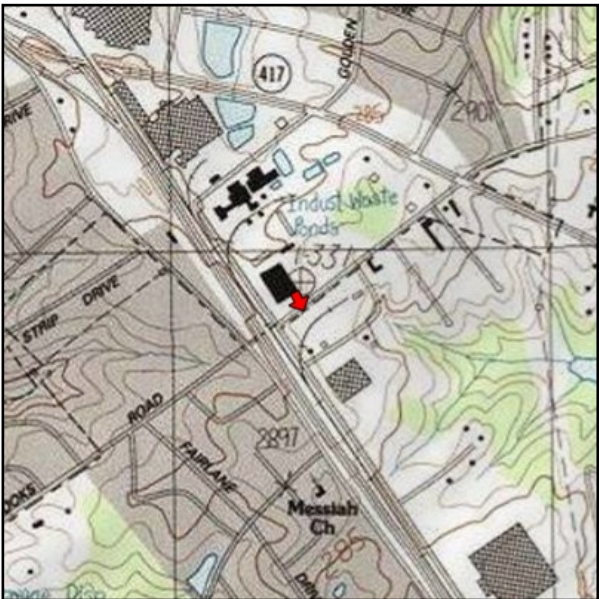
Attributes	
Description	Hand is pointing at location of Outfall #1. The facility stated that they have blocked the inlet to the outfall and no longer treat it as an outfall. Evidence of ongoing drainage off-site at this location was visible on the wet ground in the shadow.

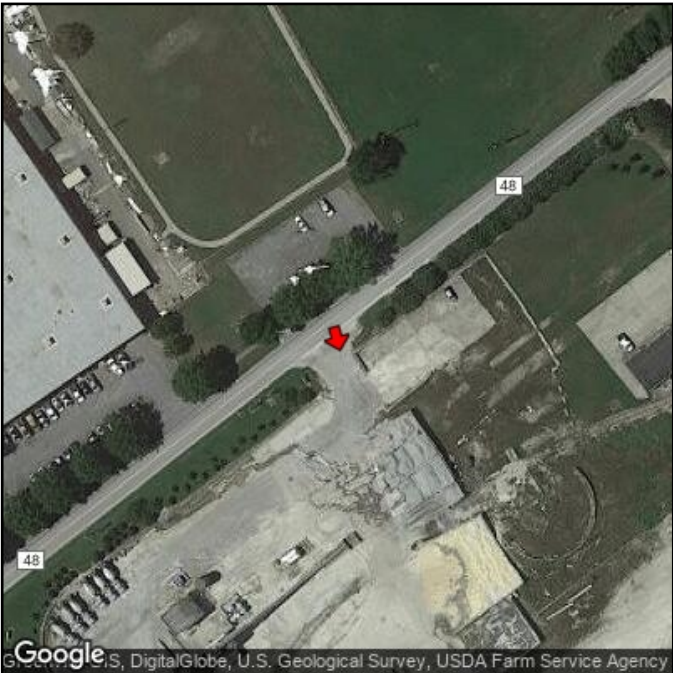
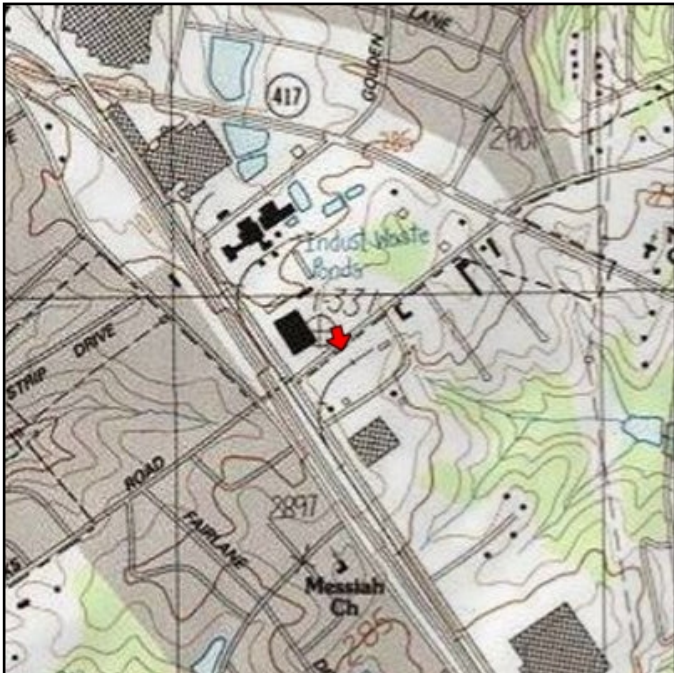
Attributes	
Description	Pile with escaped material and stormwater running off. Drainage flows to the driveway to, and ditch along, Greer Drive.

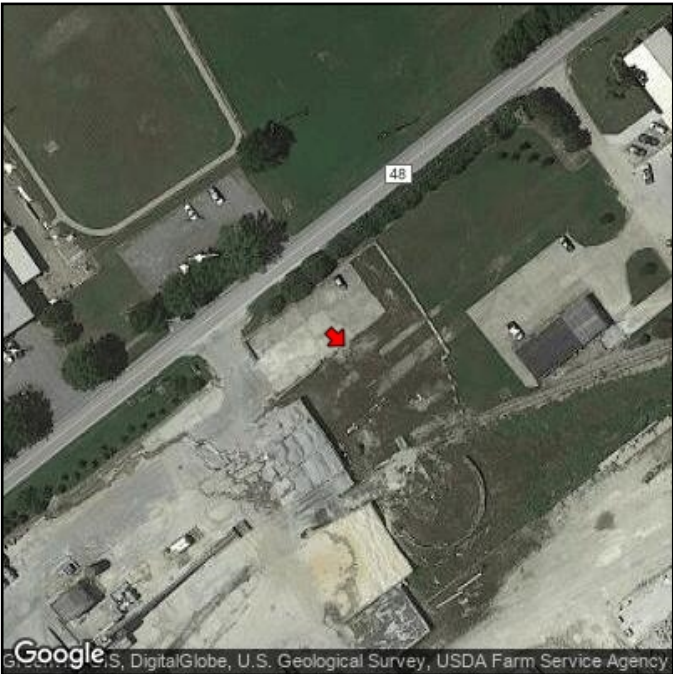
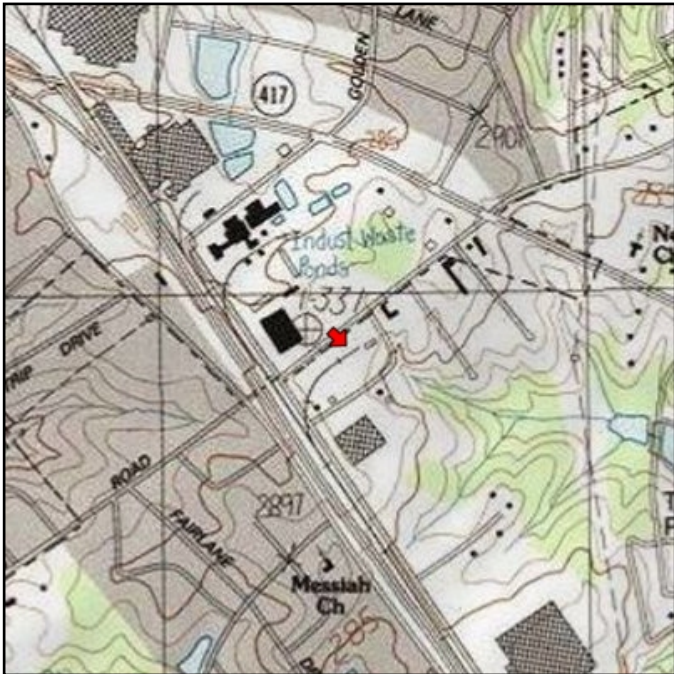
Attributes	
Description	View of concrete recycling area. Walking towards the conveyance to Outfall #1.

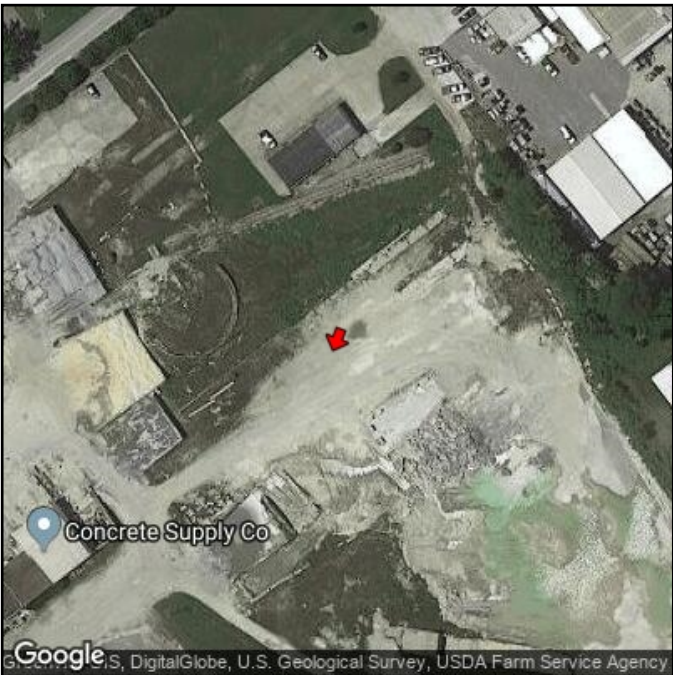
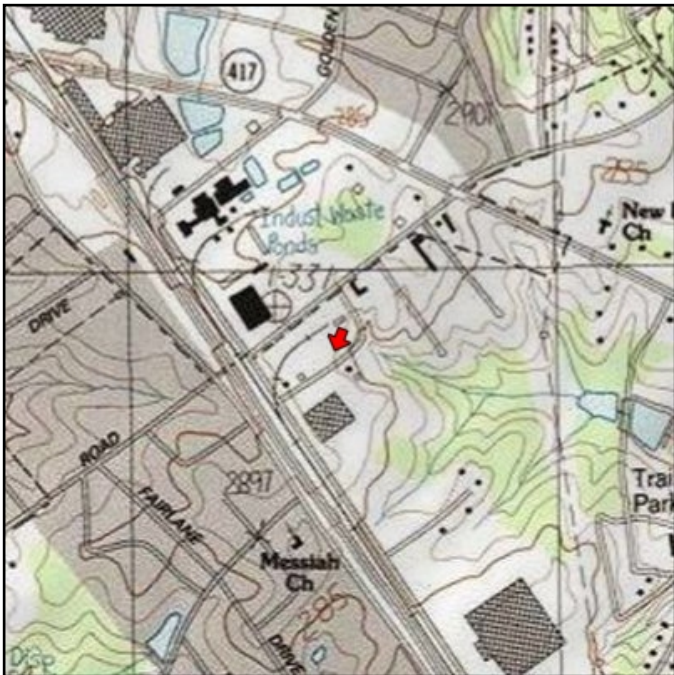
Attributes	
Description	View upgradient of water flowing towards Outfall #1 from the aggregate storage pile. The pile was being watered with city water.

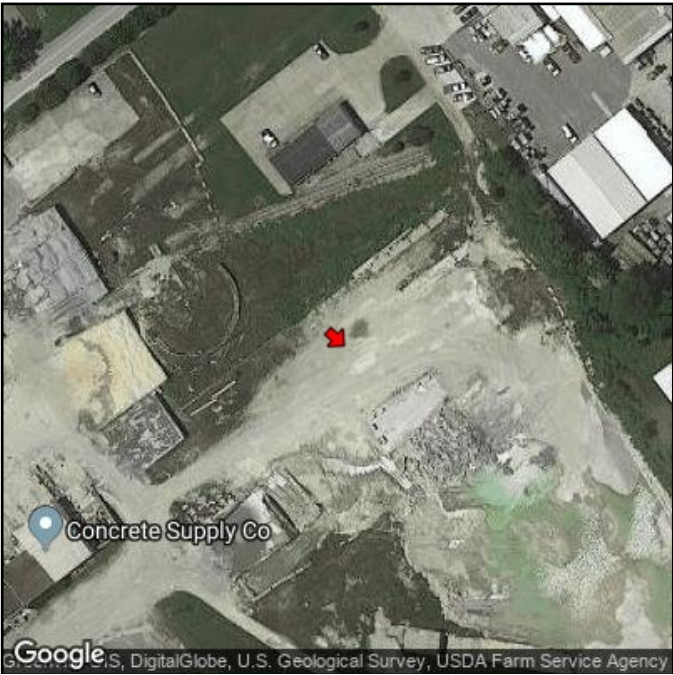
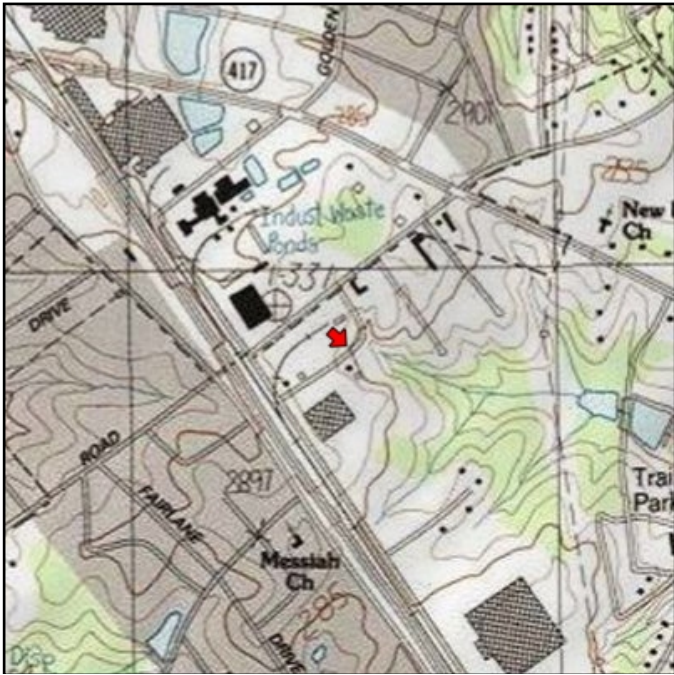
Attributes	
Description	View looking downgradient of water flowing towards Outfall #1 from the aggregate storage pile. The pile was being watered with city water.

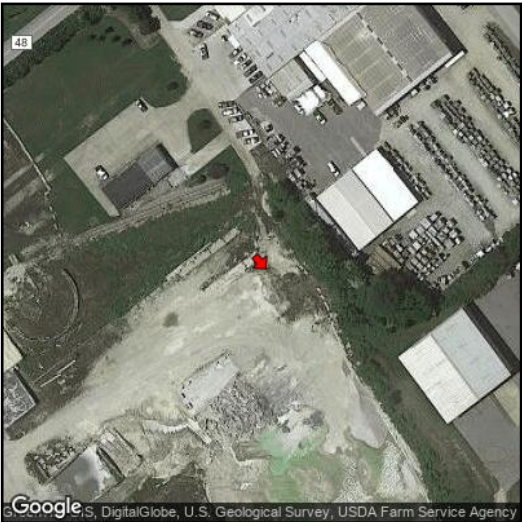
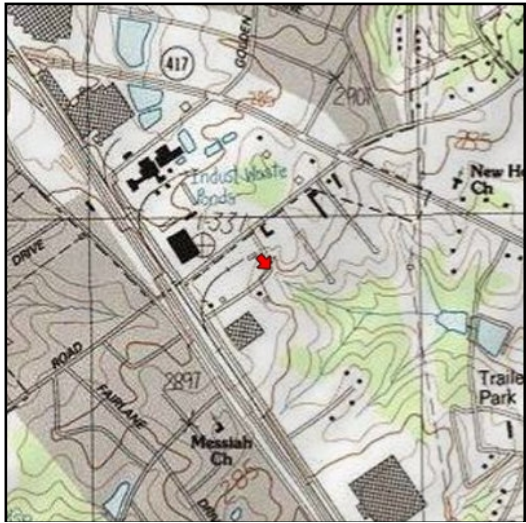
Attributes	
Description	The post in the photo is the approximate location of where the facility used to have Outfall #3. The facility stated that they moved material to block Outfall #3 and no longer treat it as an outfall. The flowing water shown in photo DSCN1507 goes under the concrete slab in the left-center of the photo. The outlet of this conveyance was not readily accessible.

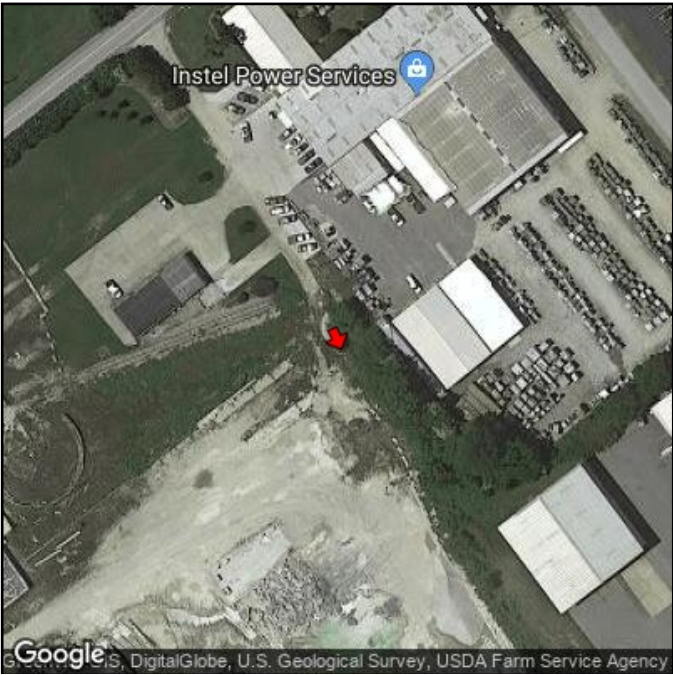
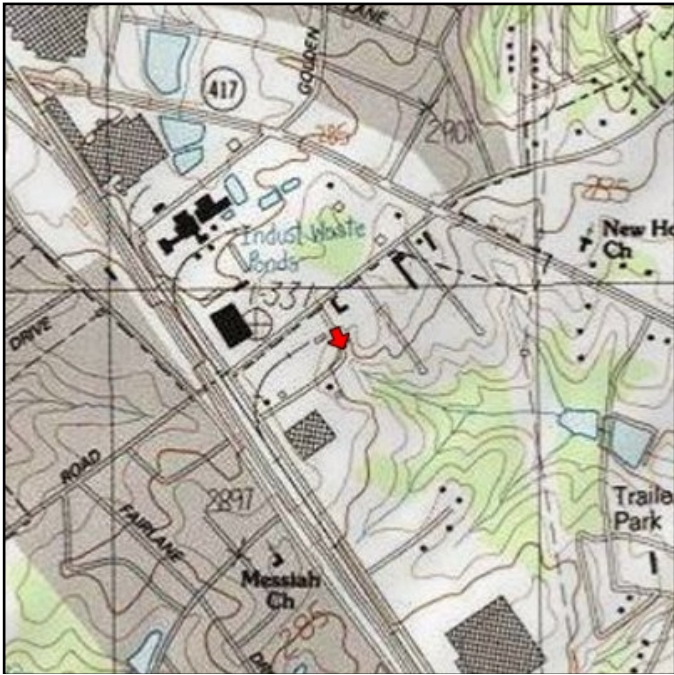
Attributes	
Description	The post in the photo is the approximate location of Outfall #3. Outfall 3 is considered to be unused by the facility. The center of the photo is a vegetated ditch along the NE property line.

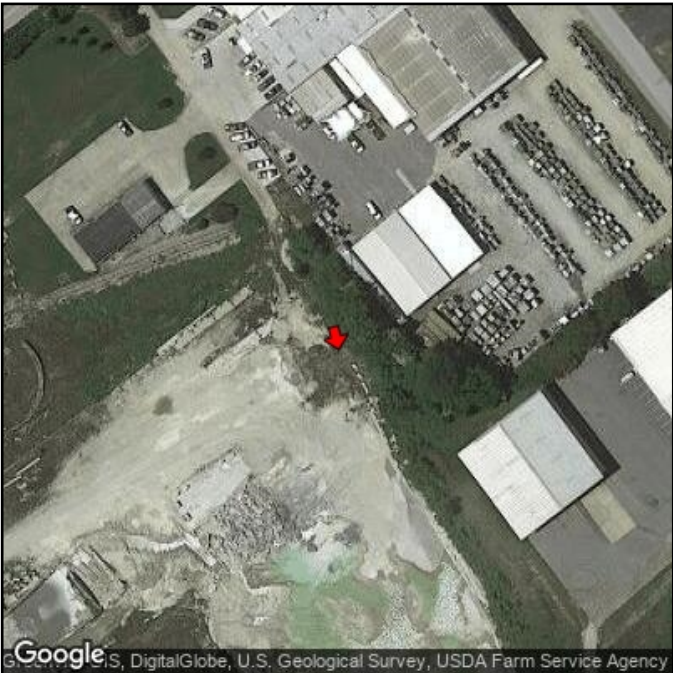
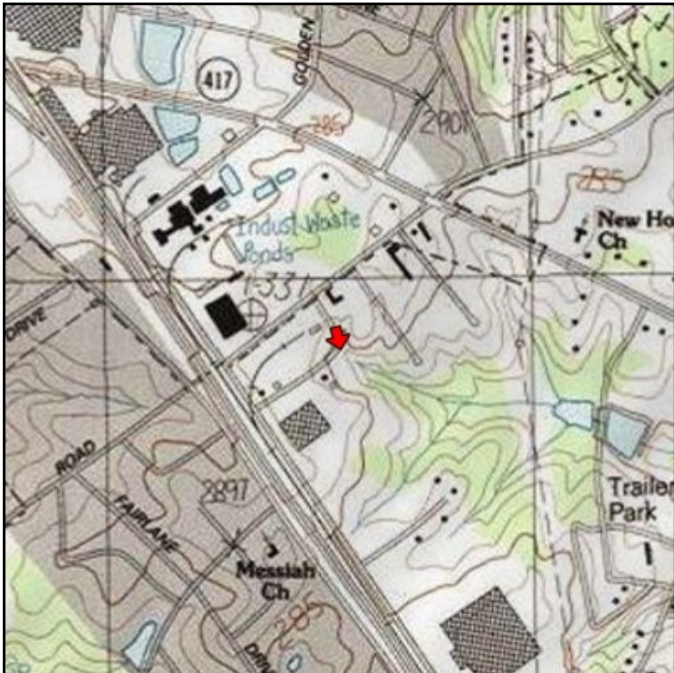
Attributes	
Description	"Returned Concrete Recycling" area with water, on the east side of the facility. Note that the water is nearly at the top of the berm in some locations.

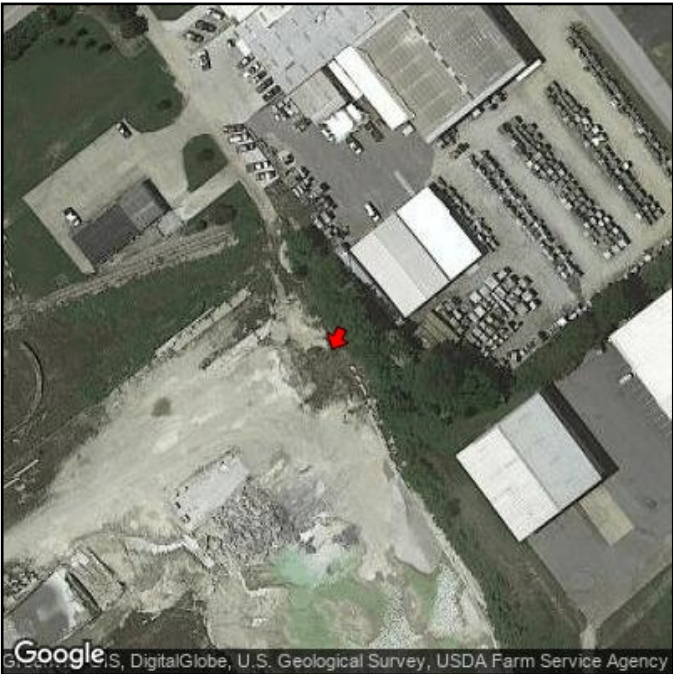
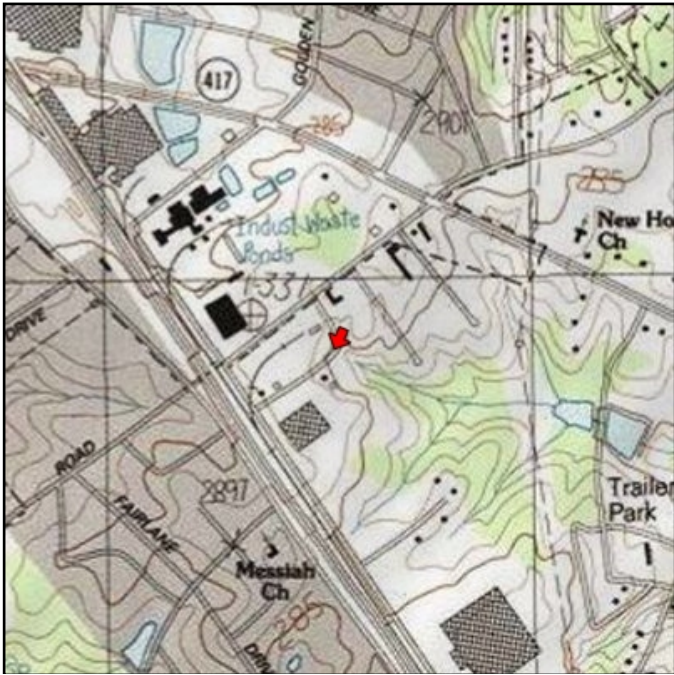
Attributes	
Description	Another view of the Returned Concrete Recycling area.

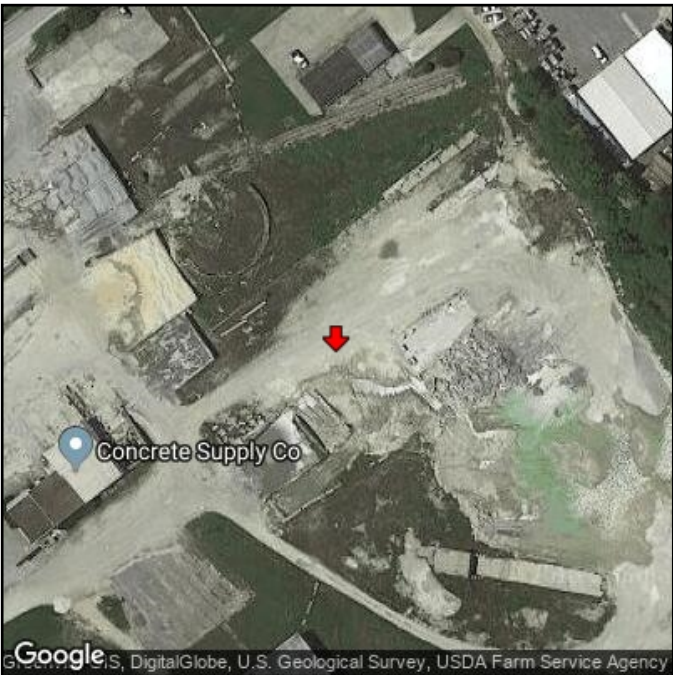
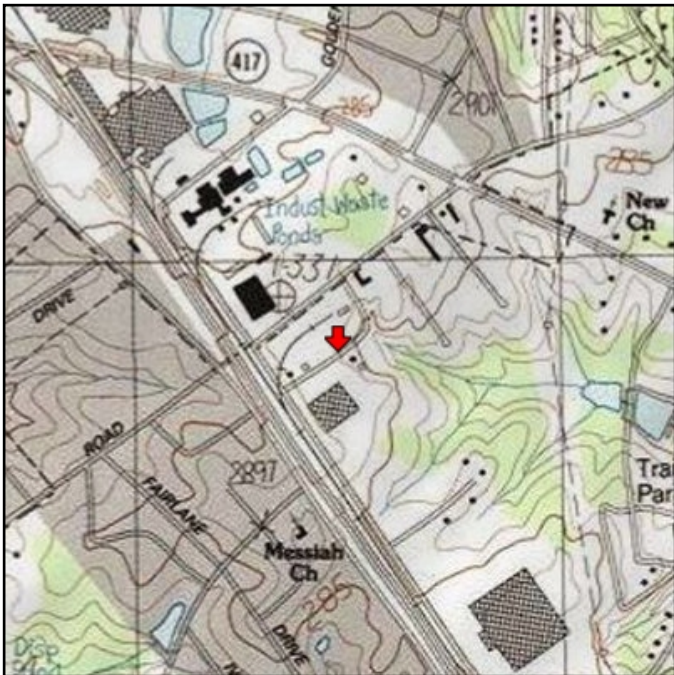
Attributes	
Description	Slurry washout area, northern end.

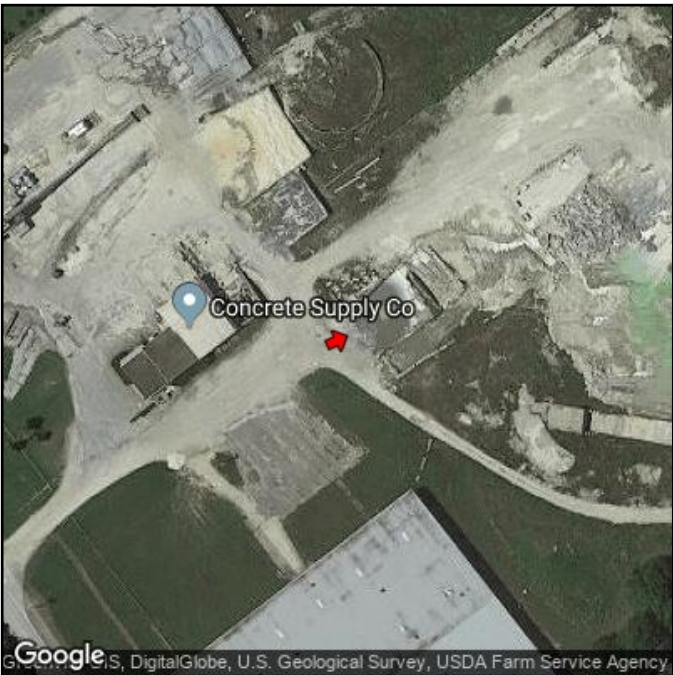
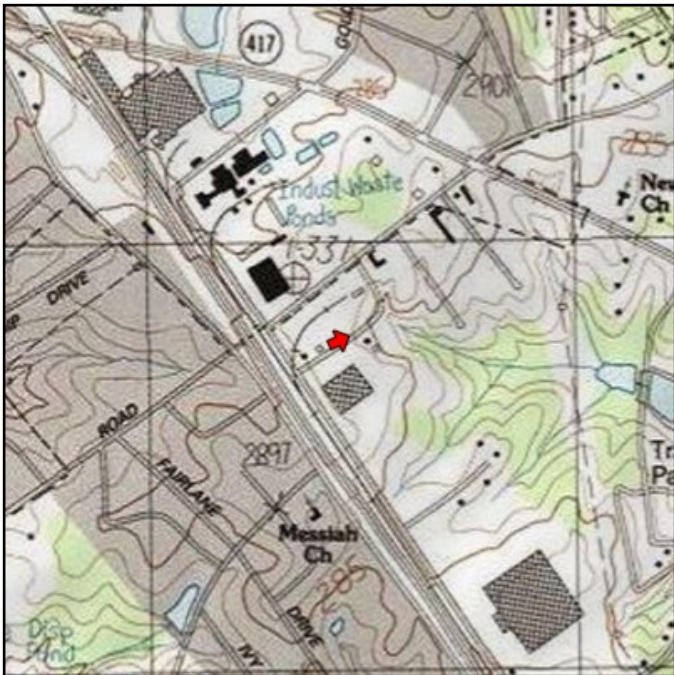
Attributes	
Description	Southwestern side of the slurry washout area. When slurry solids are mucked out, the solids are placed in piles downgradient - see back left in photo.

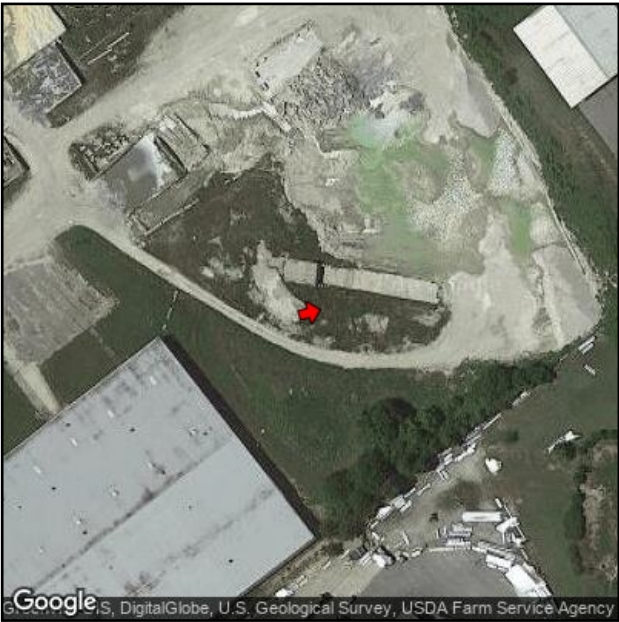
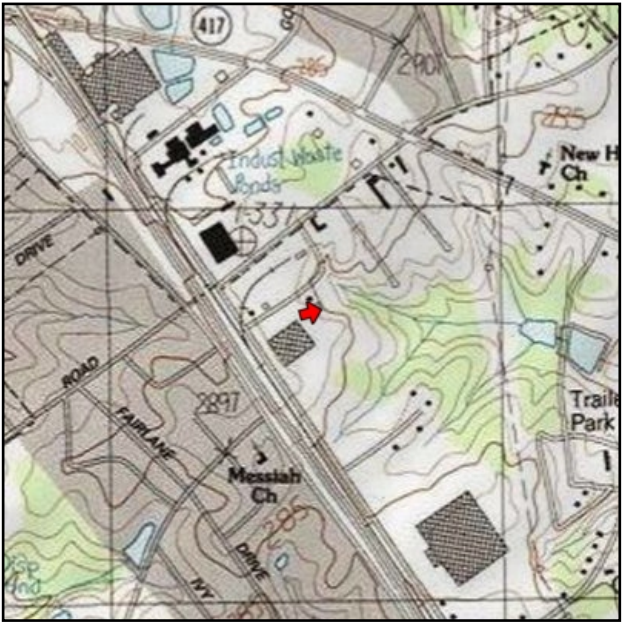
Attributes	
Description	The pond level of the concrete recycling area was near the top of the berm. The adjacent neighbor had complained about water discharge to CSC about a year prior to the inspection, and CSC increased the berm wall height after the complaint.

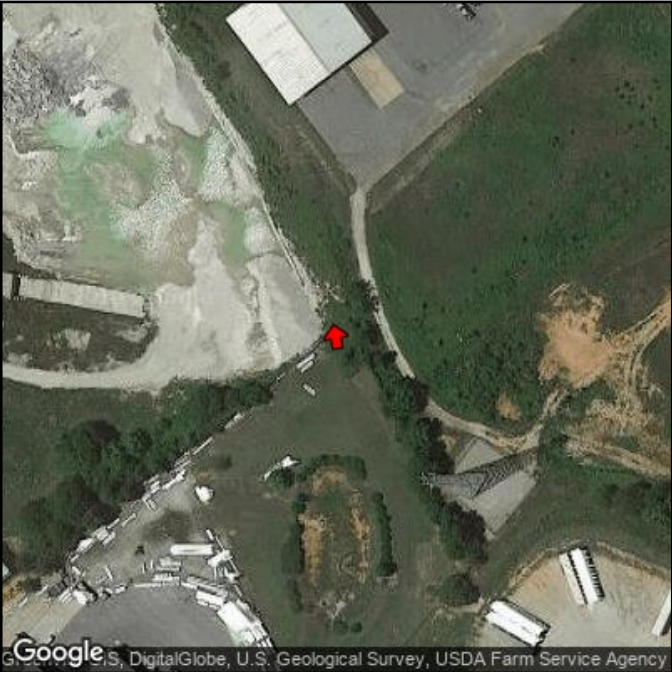
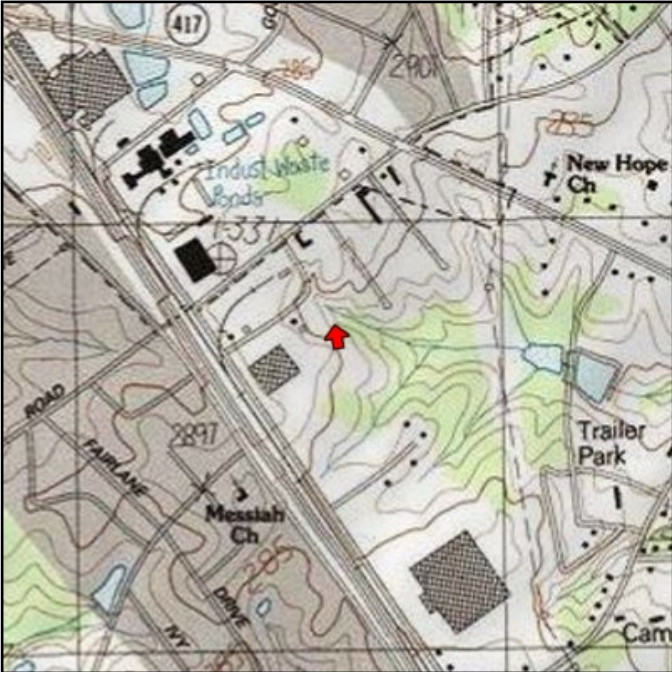
Attributes	
Description	The water in the concrete recycling area pond level is near the top of the berm.

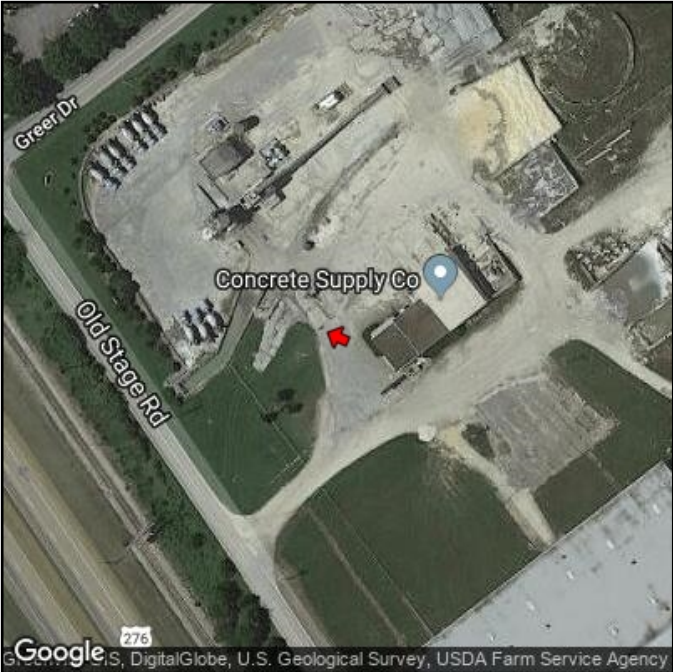
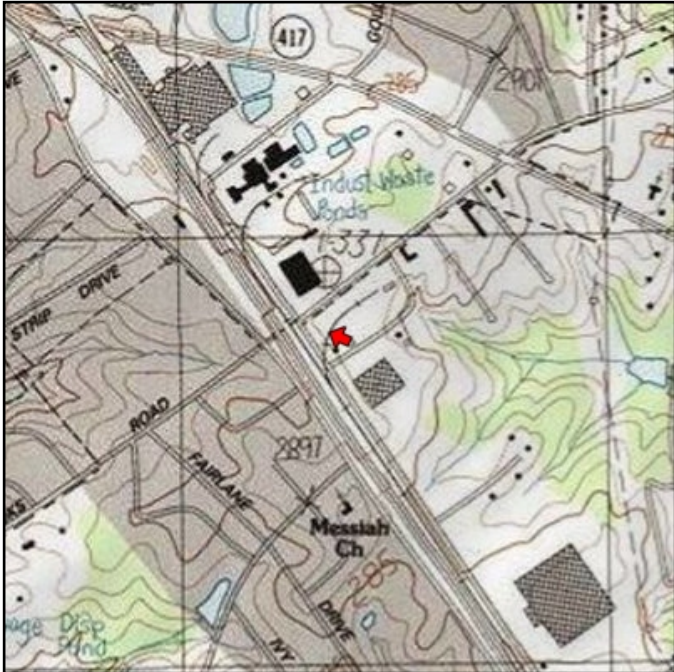
Attributes	
Description	Former rail spur at front of facility. Stormwater Outfall #2 is along that line (gravel, mid-photo).

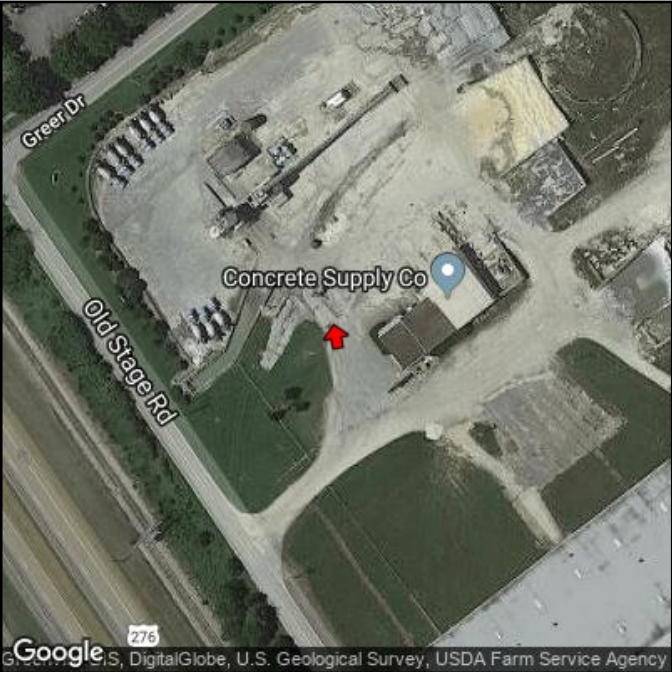
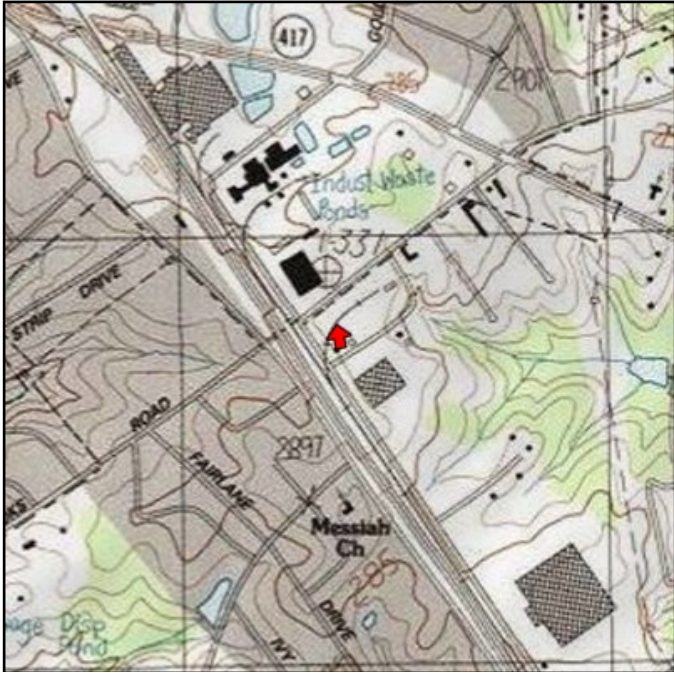
Attributes	
Description	Foreground is truck wash area; ready-mix tower in background.

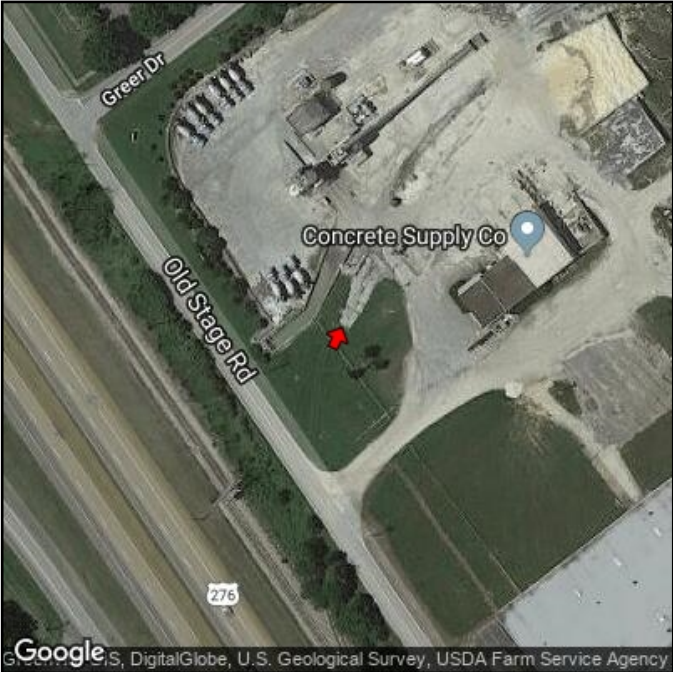
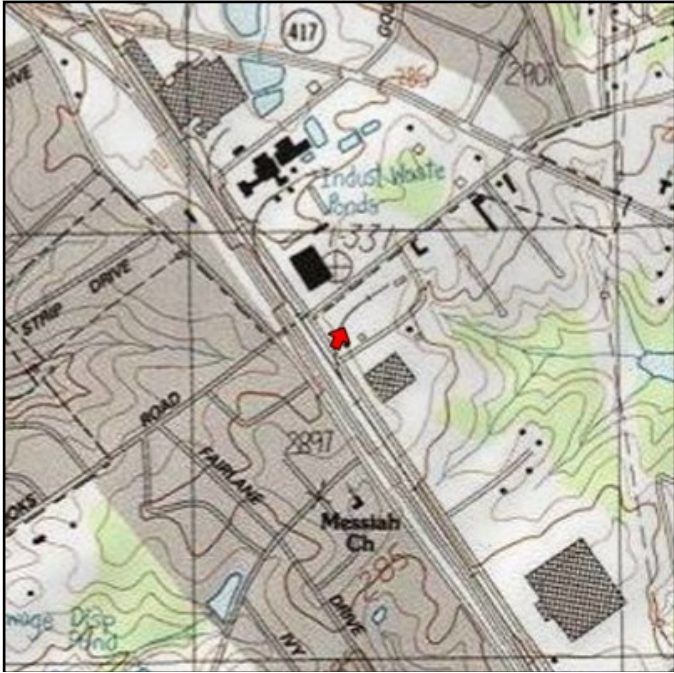
Attributes	
Description	Stormwater Outfall #2. Water flows southwesterly, towards photographer.

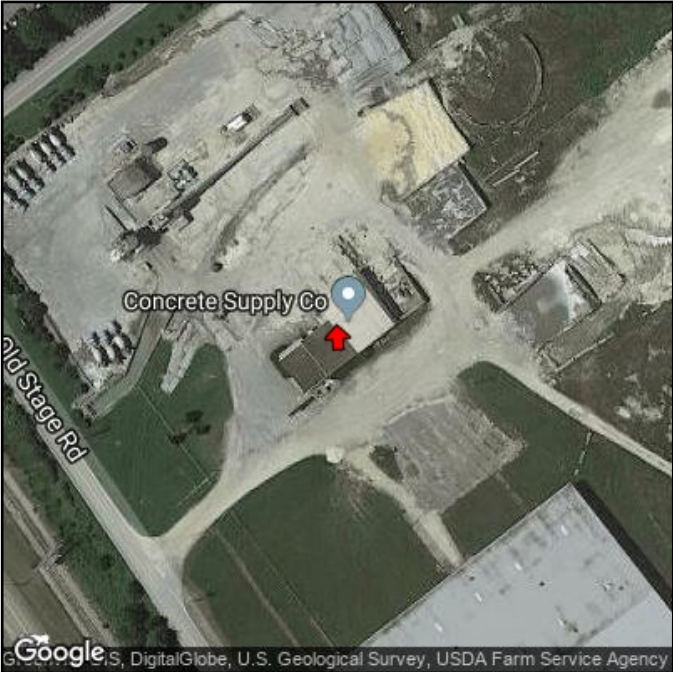
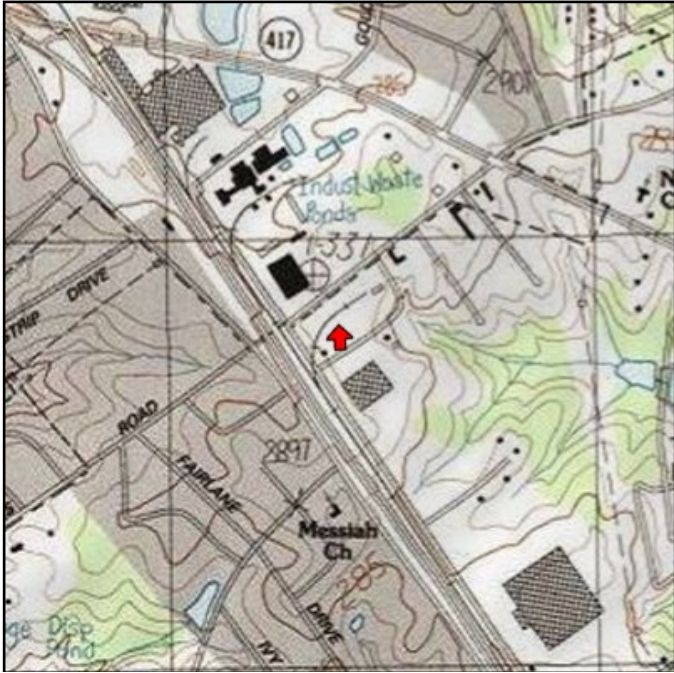
Attributes	
Description	Fluids for truck maintenance and other materials are stored in this building.

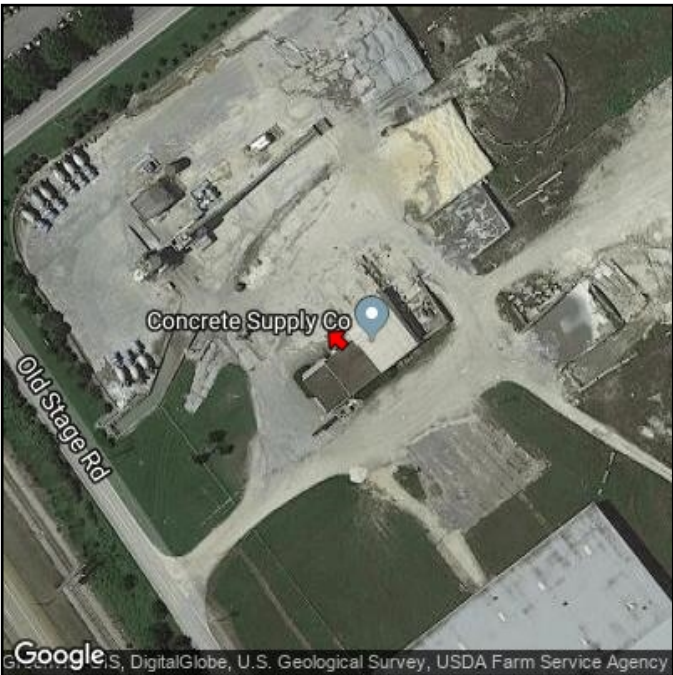
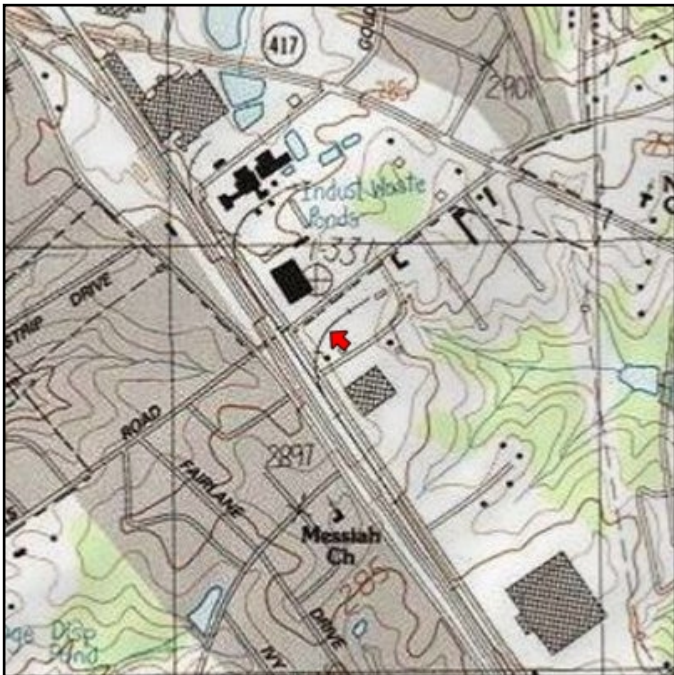
Attributes	
Description	Mixing and dispensing facilities - the tote at the left serves the truck wash station and the tanks center-right are liquids ad-mixes for various concrete mixes.

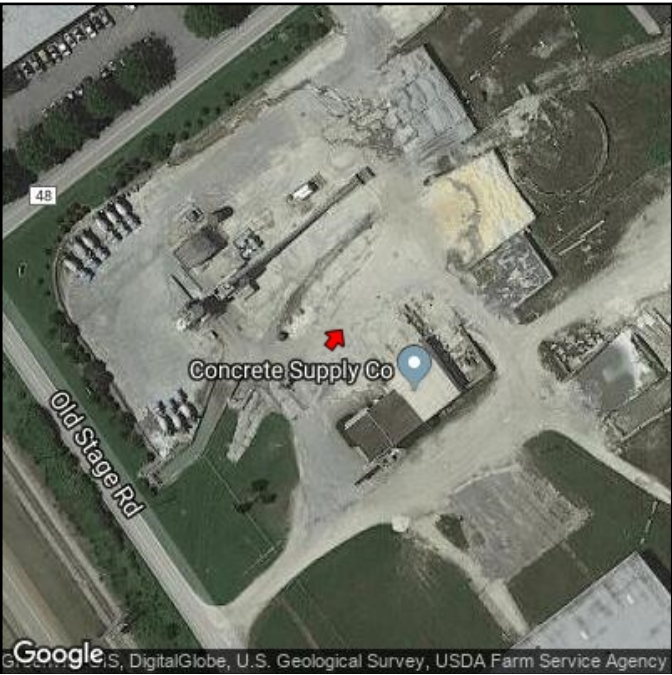
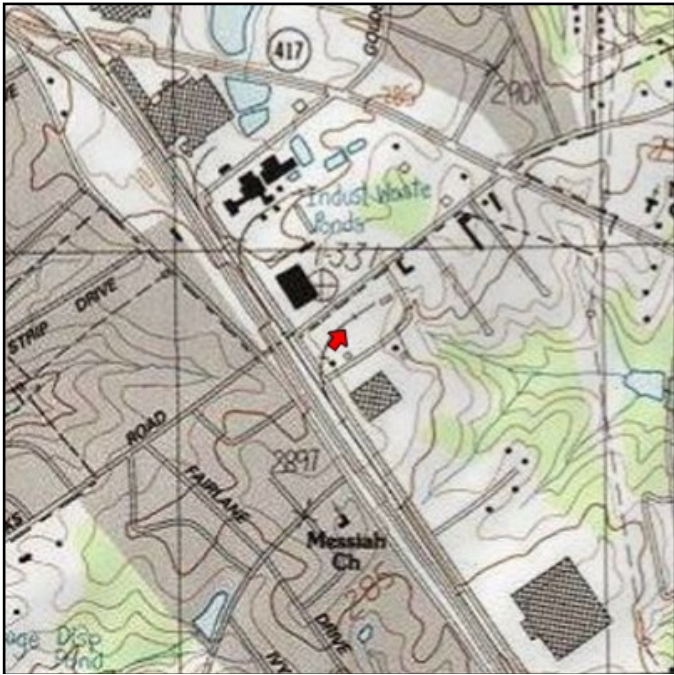
Attributes	
Description	Sand and other piles are exposed to rainwater.

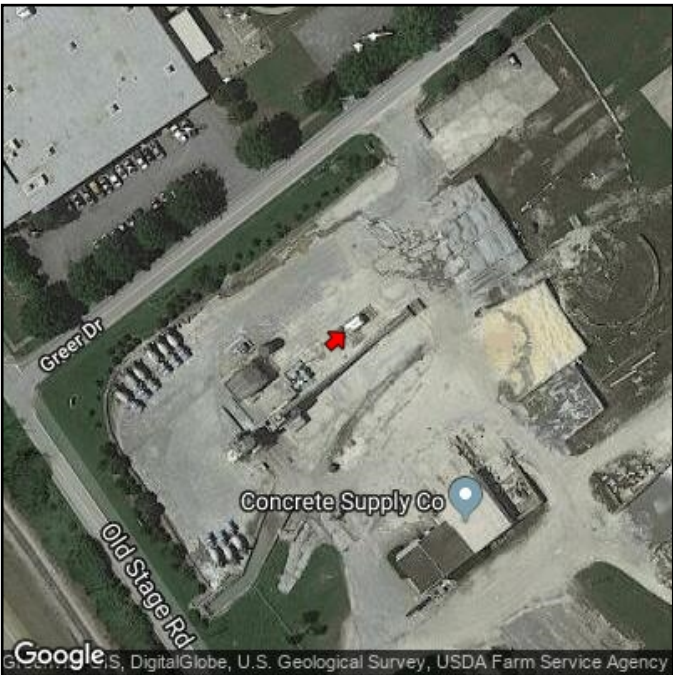
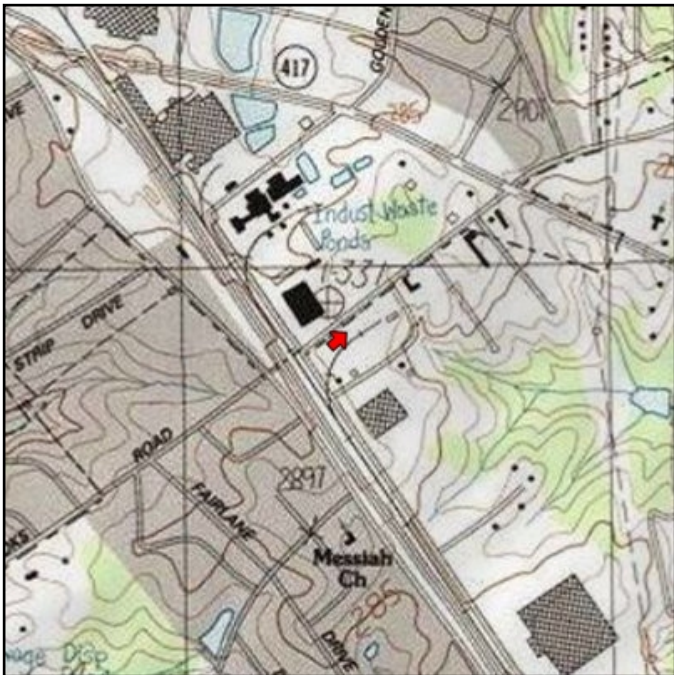
Attributes	
Description	Diesel fill station - double walled fuel tank with bollards and filling plumbing.

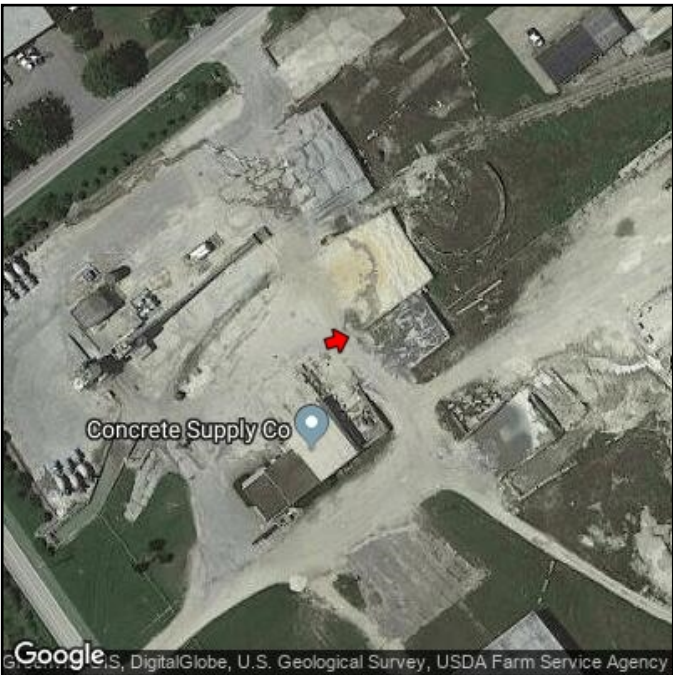
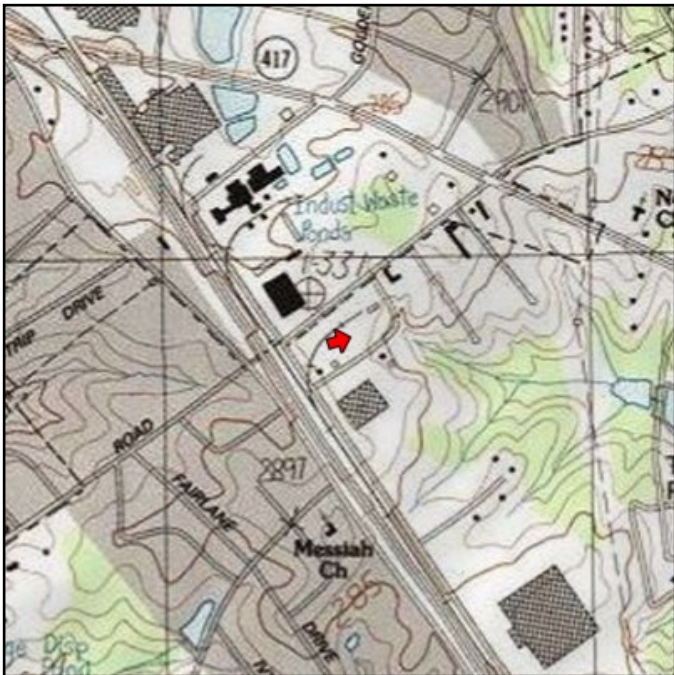
DSCN1524.JPG

Attributes	
Description	Pile of light weight aggregate. This pile is sprayed with municipal water through sprinklers.

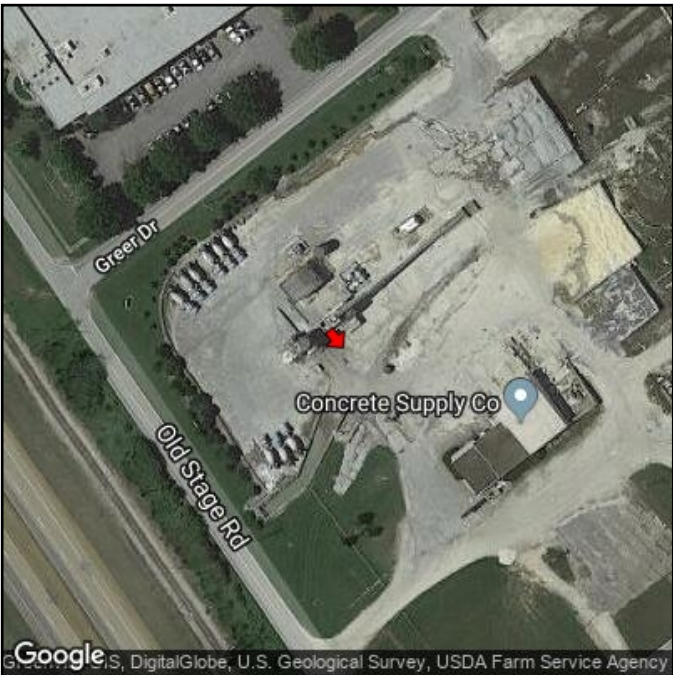
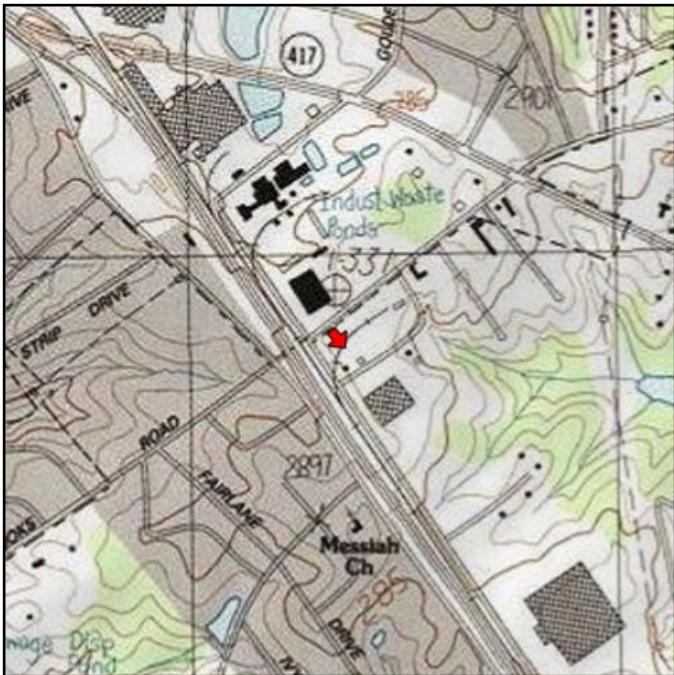
Attributes	
Description	Recycled water basin at left-center, and truck washdown station foreground and right.

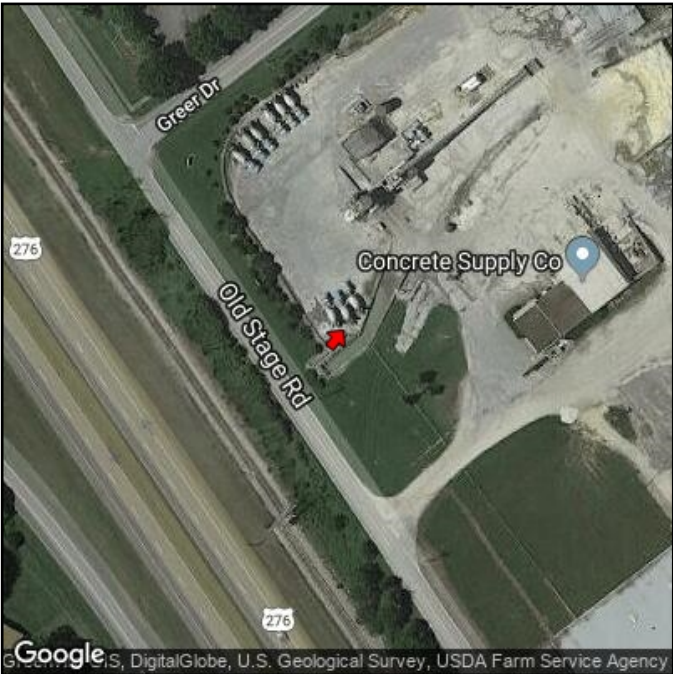
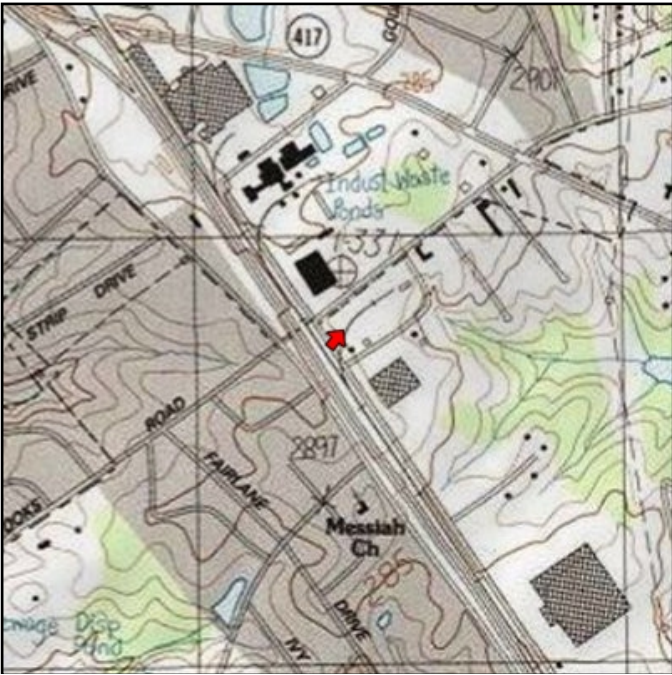
Attributes	
Description	A closer view of the inlet side of water pump equipment at the recycle water basin. Water level is about 3 inches from overflowing.

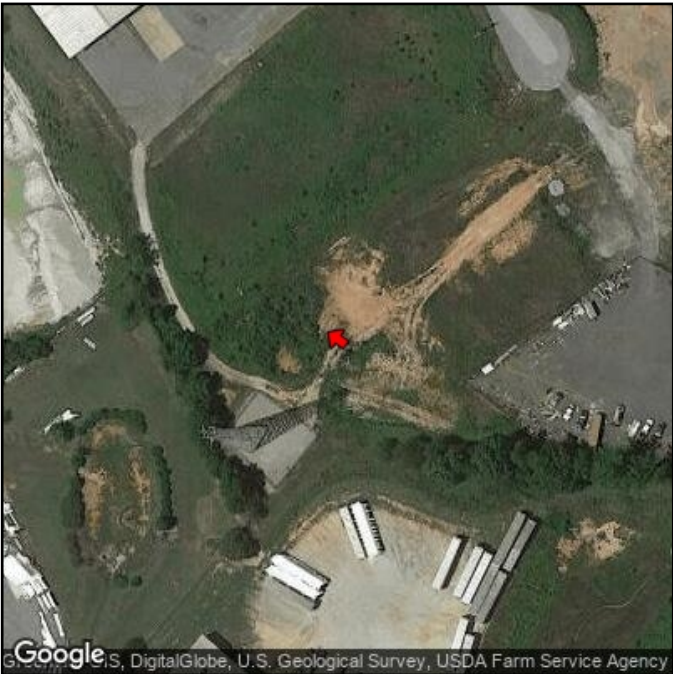
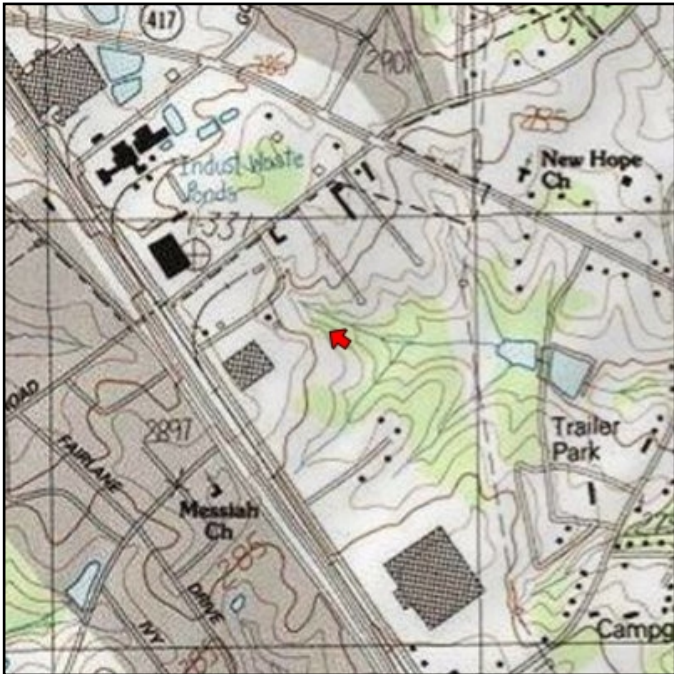
Attributes	
Description	Water from the area of the berm surrounding the concrete recycle area (horizon/background center-right) flows towards the photographer.
